Emergency Response Plan Documentation Report

12th Street Landfill
Plainwell, Michigan

July 2008

RMT, Inc. | Weyerhaeuser Company
Final

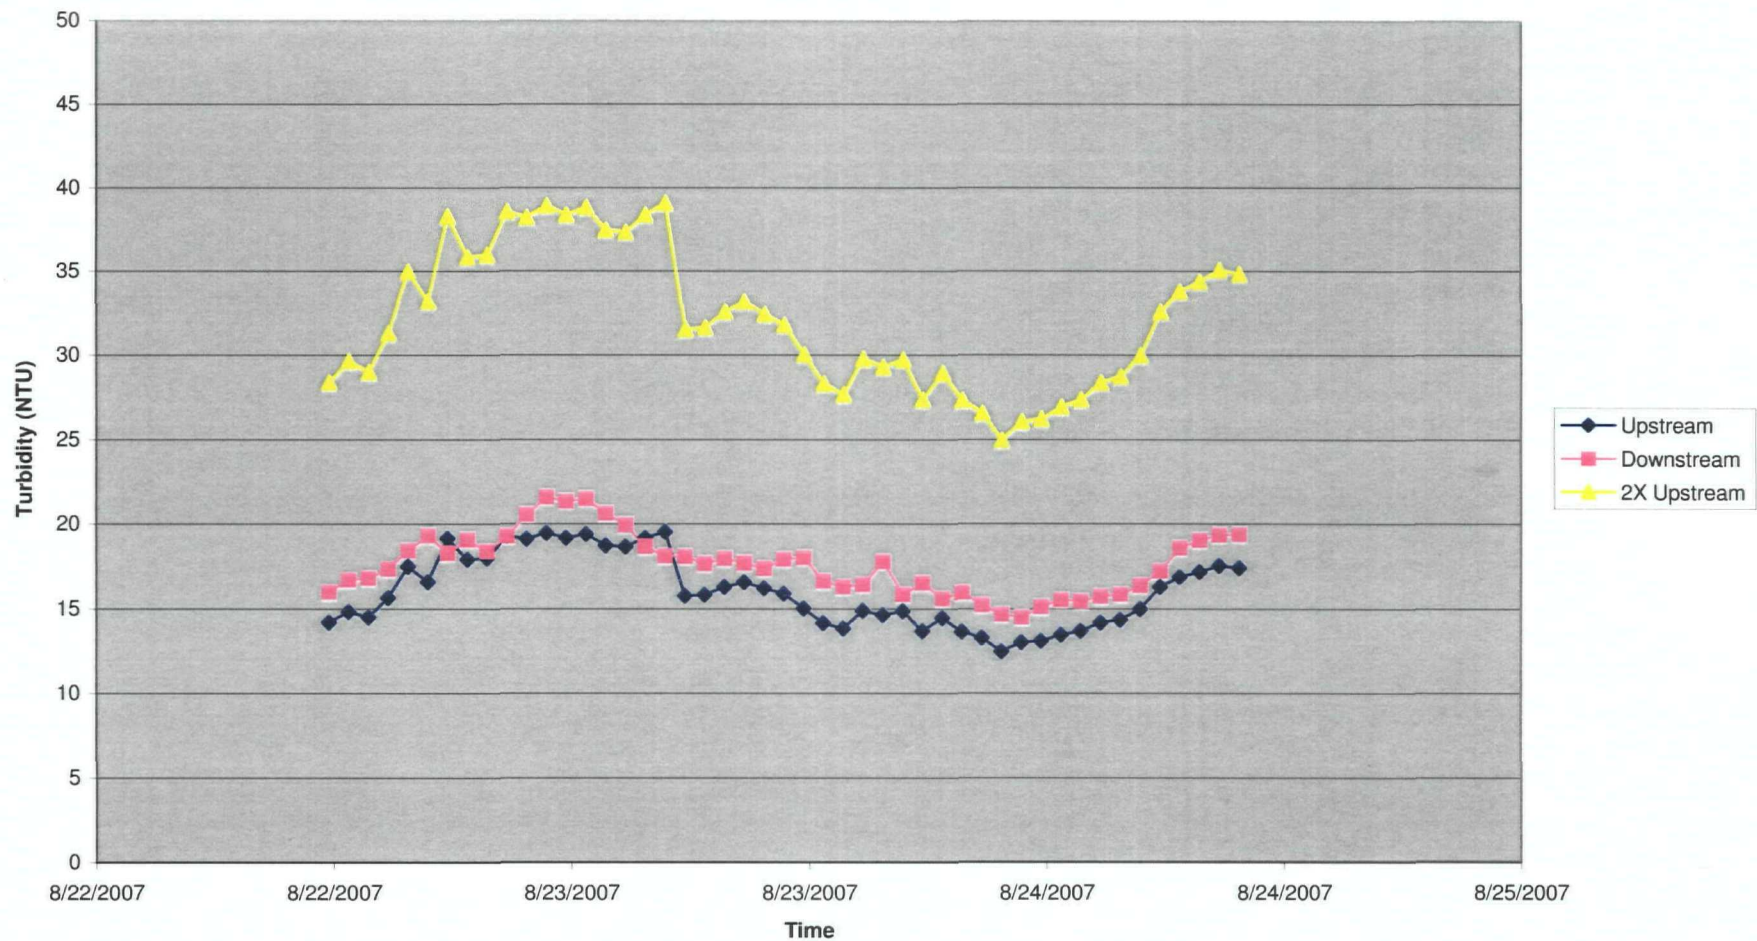
Figure 6-1
Turbidity Data 8/22/2008 - 8/24/2008
Powerhouse Channel - 12th Street Landfill - Plainwell, MI

Note:
 Actions taken regarding exceedances are explained on Table 1.

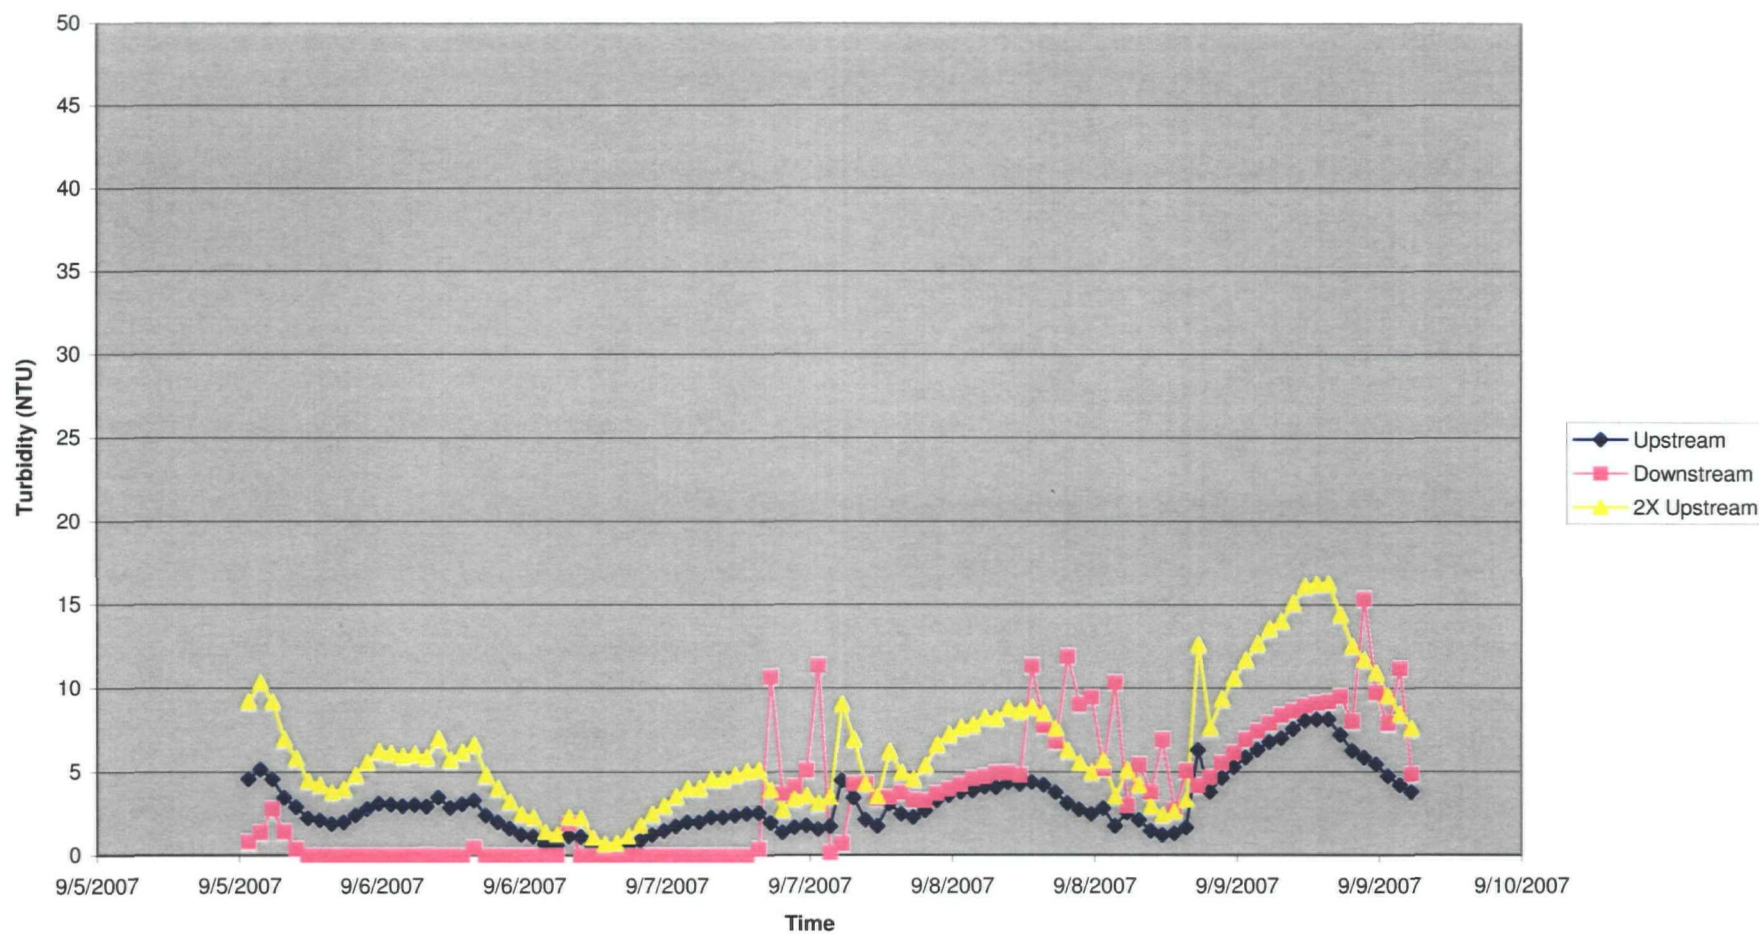
Figure 6-2
 Turbidity Data 9/5/2008 - 9/9/2008
 Powerhouse Channel - 12th Street Landfill - Plainwell, MI

Note:
 Actions taken regarding exceedances are explained on Table 1.

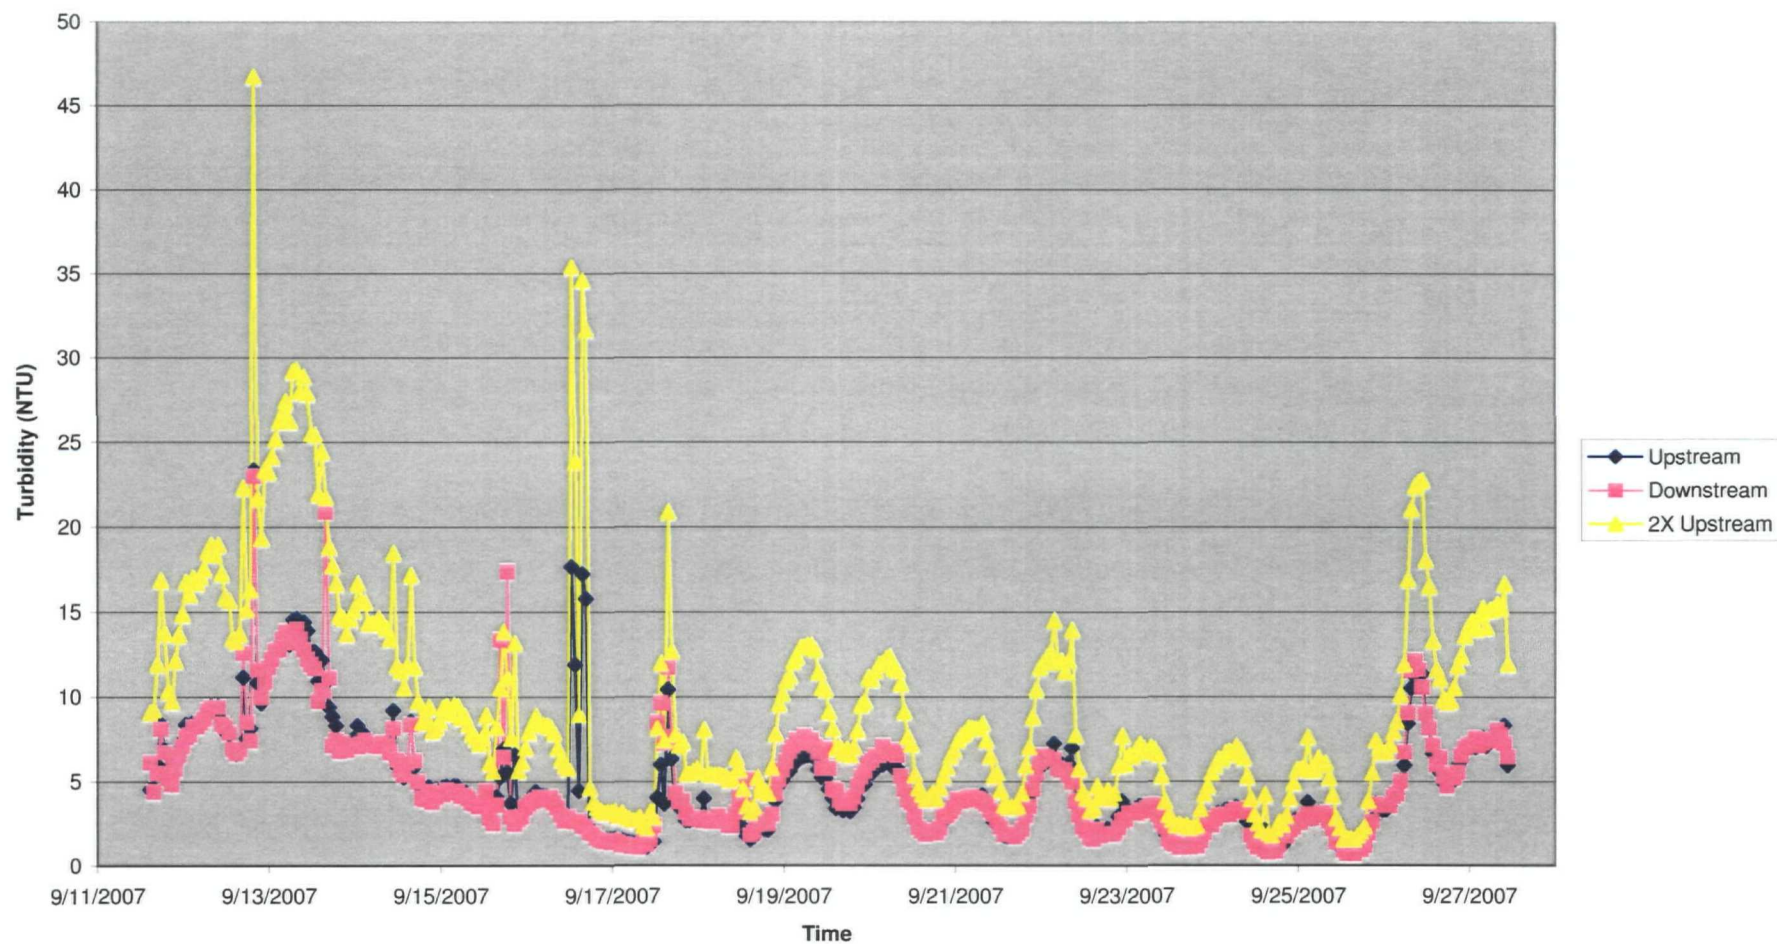
Figure 6-3
Turbidity Data 9/11/2008 - 9/27/2008
Powerhouse Channel - 12th Street Landfill - Plainwell, MI

Note:
 Actions taken regarding exceedances are explained on Table 1.

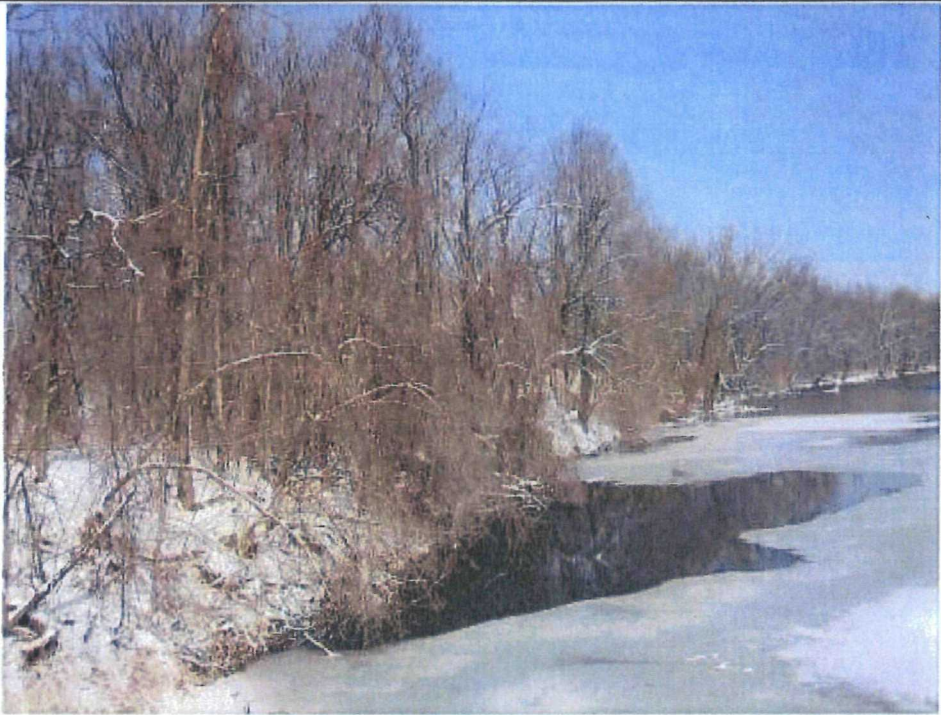
Client Name: Weyerhaeuser		Site Location: Plainwell, Michigan	Project No.: 00-05131.03
Photo No. 1	Date 3/07/2007

Description Plainwell Dam looking downstream at former powerhouse channel

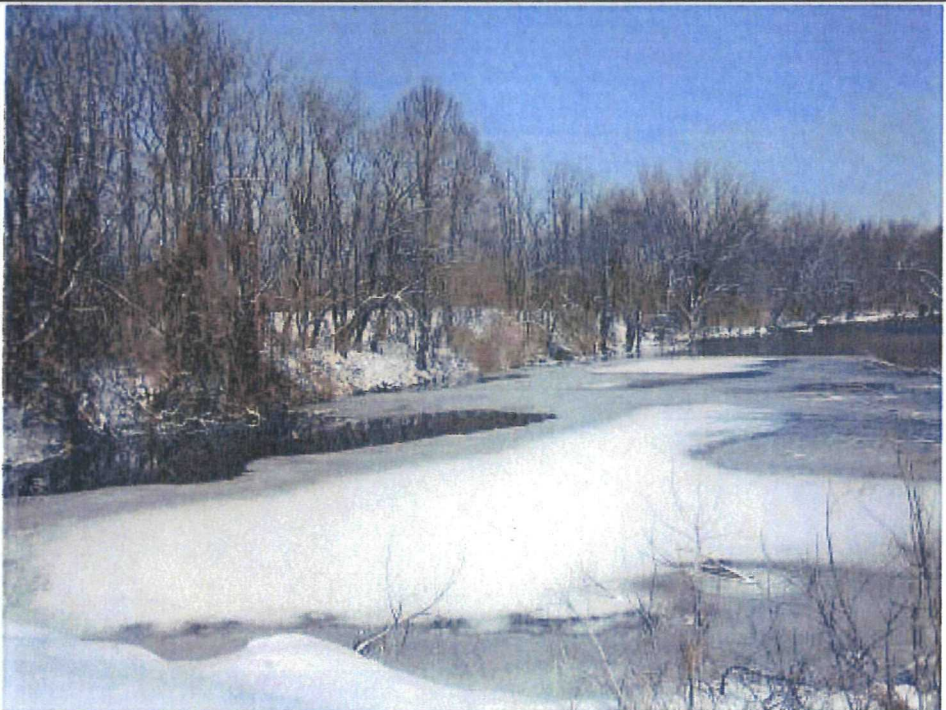
Photo No. 2	Date 3/07/2007

Description From Plainwell Dam looking at bank of 12 th Street Landfill

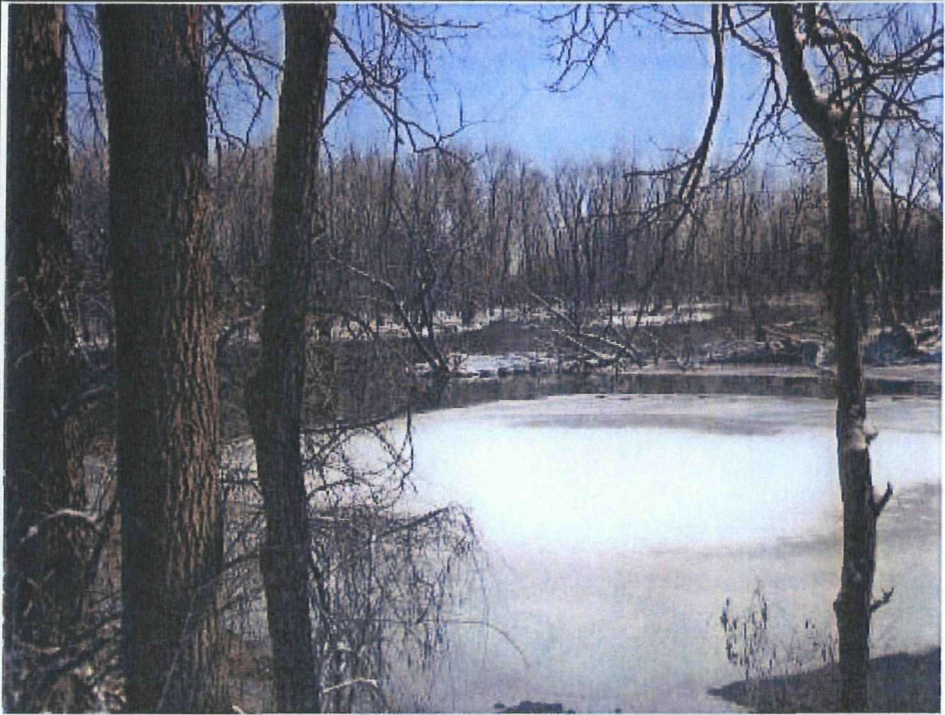
Client Name: Weyerhaeuser		Site Location: Plainwell, Michigan	Project No.: 00-05131.03
Photo No. 3	Date 3/07/2007

Description View from 12 th St. Landfill looking East

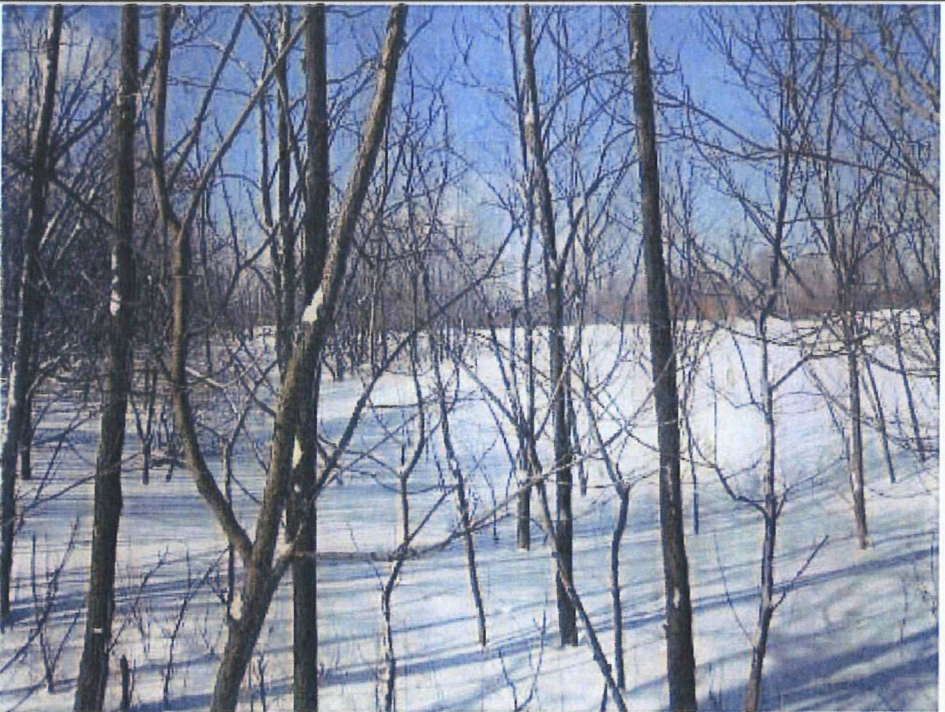
Photo No. 4	Date 3/07/2007

Description Top of 12 th St. Landfill looking west

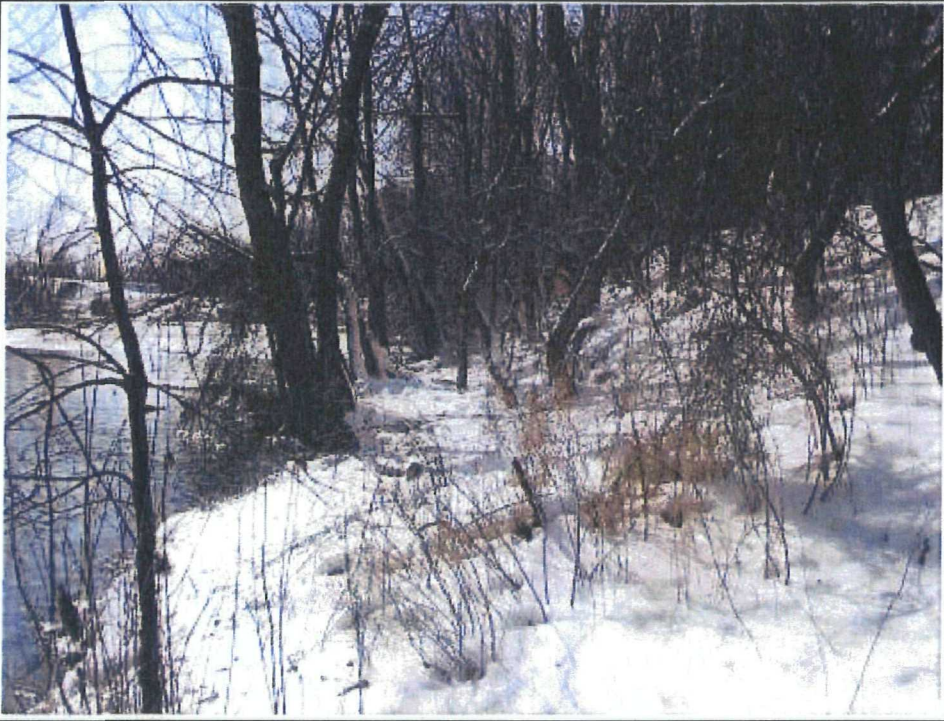
Client Name: Weyerhaeuser		Site Location: Plainwell, Michigan	Project No.: 00-05131.03
Photo No. 5	Date 3/07/2007

Description View from 12 th St. Landfill bank looking towards Plainwell Dam			
Photo No. 6	Date 3/07/2007

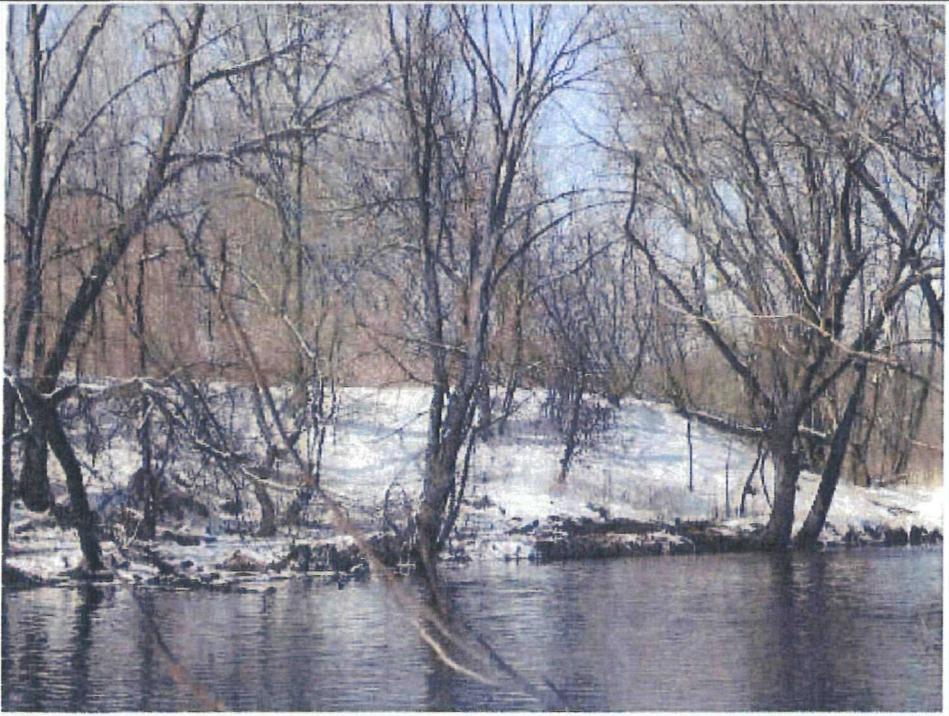
Description 12 th St. Landfill looking from peninsula on Plainwell Dam

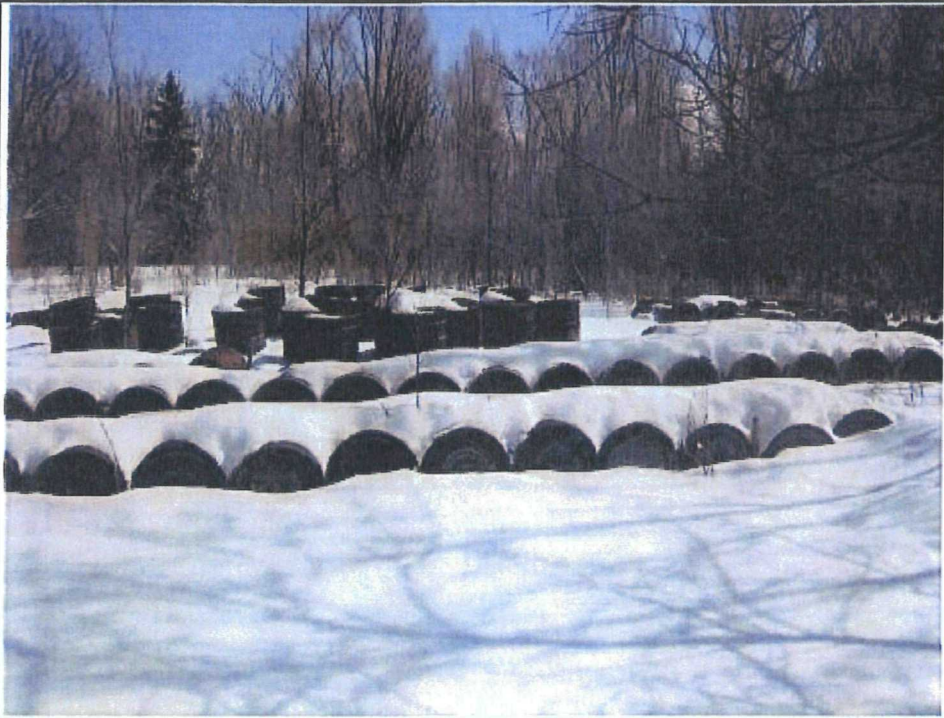
Client Name: Weyerhaeuser		Site Location: Plainwell, Michigan	Project No.: 00-05131.03
Photo No. 7	Date 3/07/2007

Description USEPA investigative derived waste drums from the Plainwell Mill property

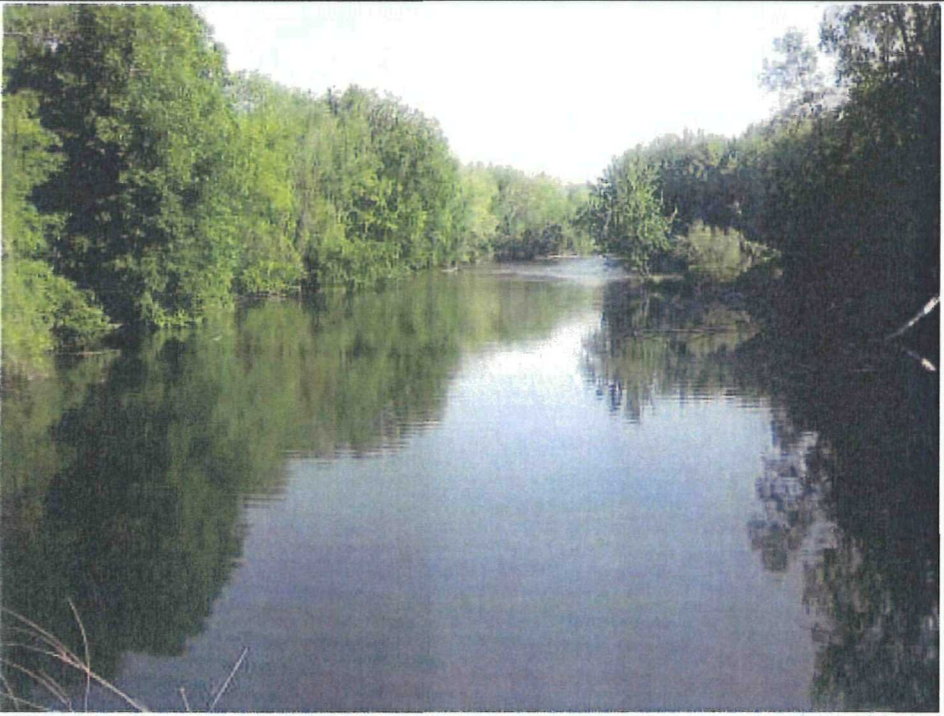
Photo No. 8	Date 5/22/2007

Description Powerhouse Channel looking downstream

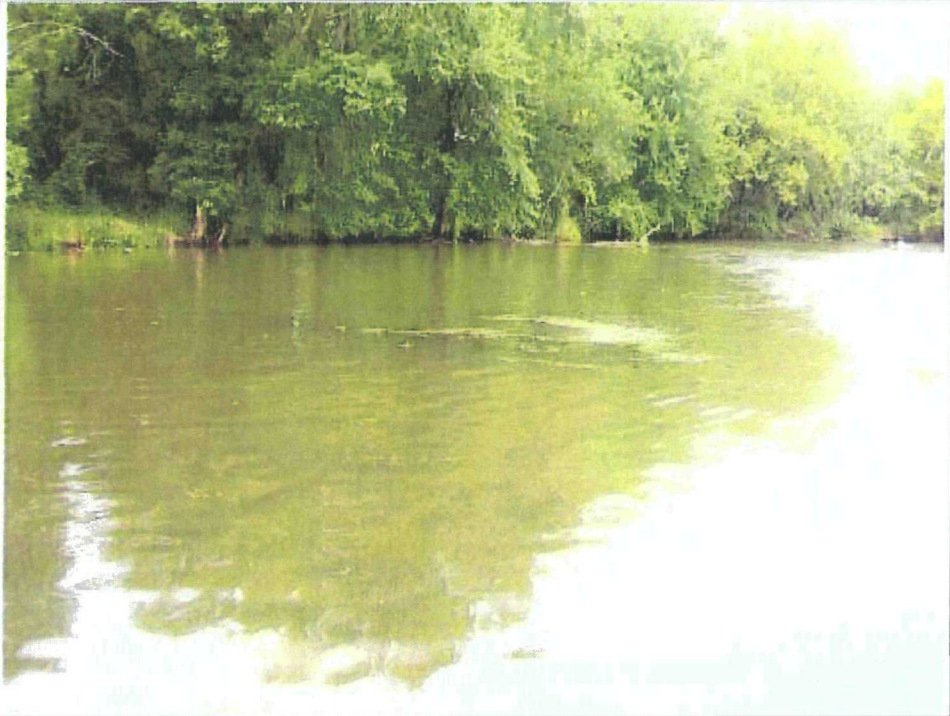
Client Name: Weyerhaeuser		Site Location: Plainwell, Michigan	Project No.: 00-05131.03
Photo No. 9	Date 8/07/2007

Description Powerhouse channel looking towards 12 th Street Landfill

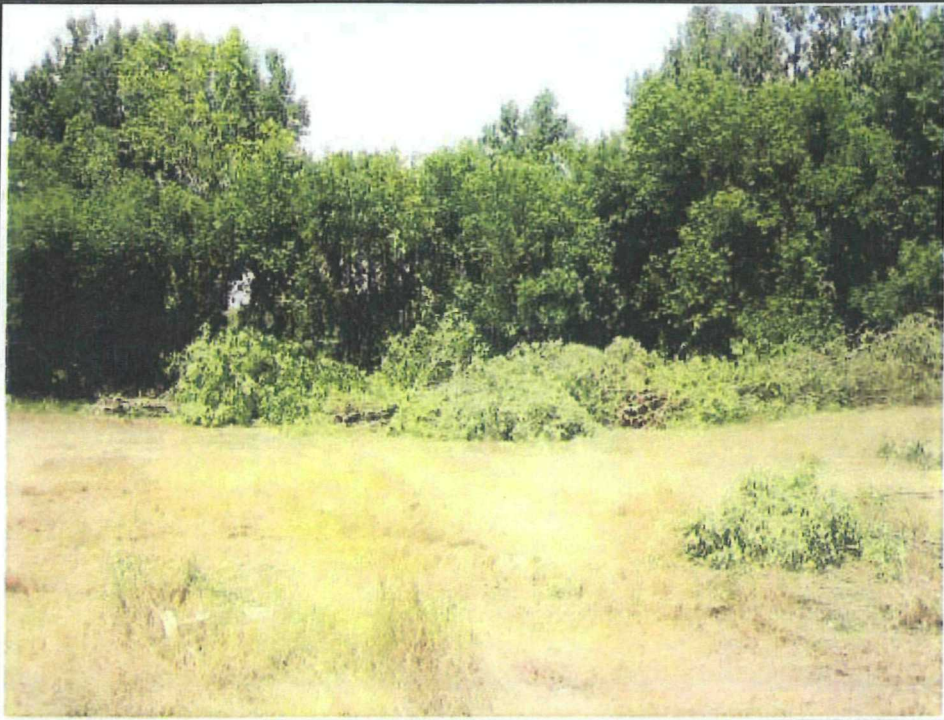
Client Name: Weyerhaeuser		Site Location: Plainwell, Michigan	Project No.: 00-05131.03
Photo No. 11	Date 8/08/2007

Description Top of 12 th Street landfill after initial clearing.

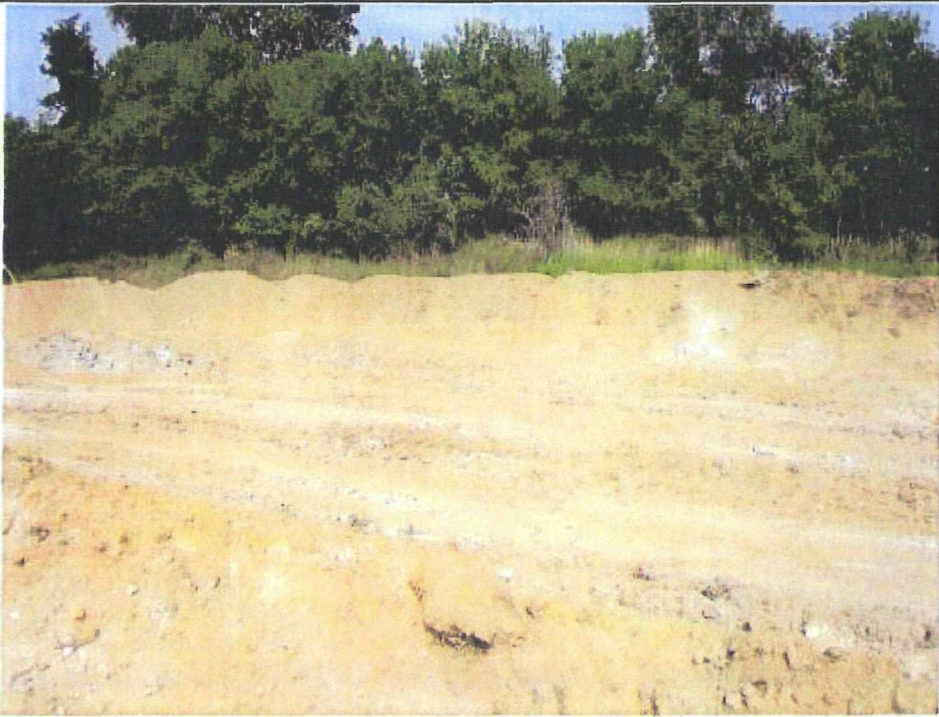
Client Name: Weyerhaeuser		Site Location: Plainwell, Michigan	Project No.: 00-05131.03
Photo No. 13	Date 8/08/2007

Description Construction of containment Pad top of landfill

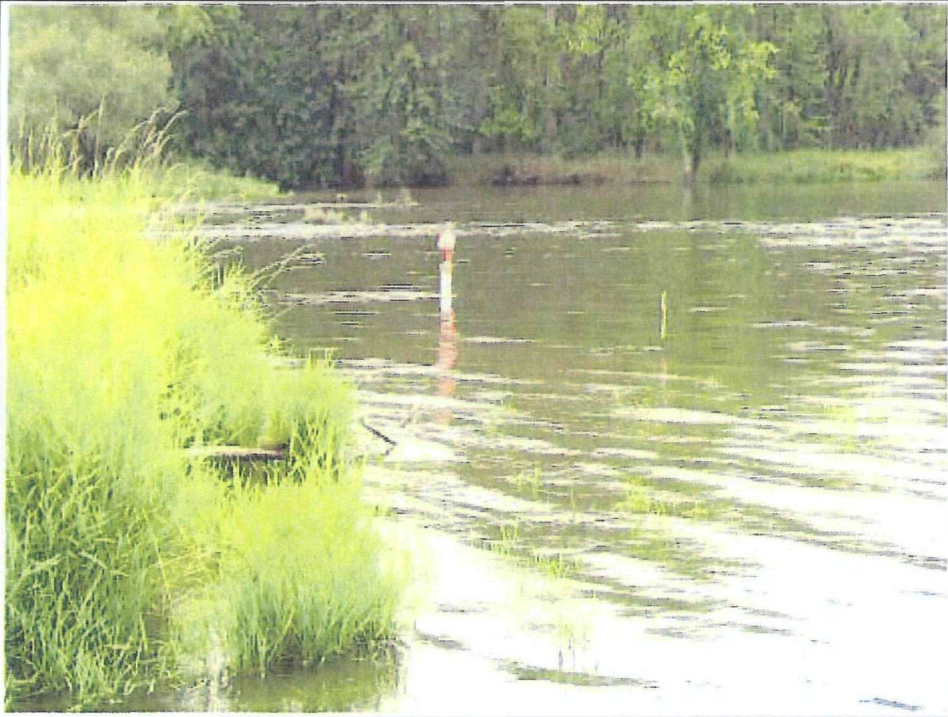
Photo No. 14	Date 8/16/2007

Description Upstream sampling point between dam and power channel outlet

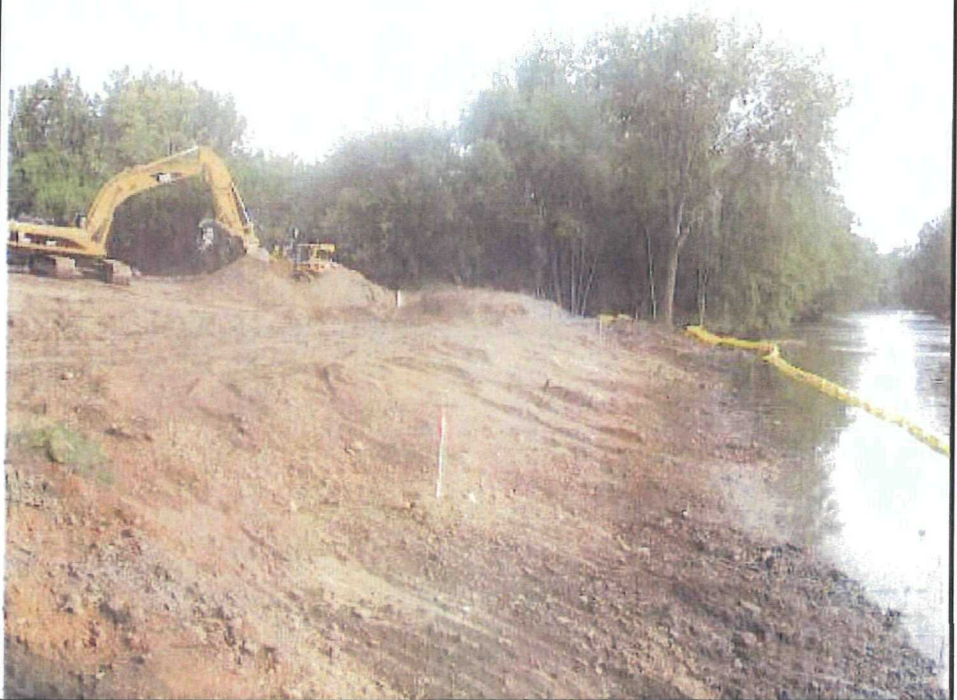
Client Name: Weyerhaeuser		Site Location: Plainwell, Michigan	Project No.: 00-05131.03
Photo No. 15	Date 8/17/2007

Description Reshaping of bank along shoreline

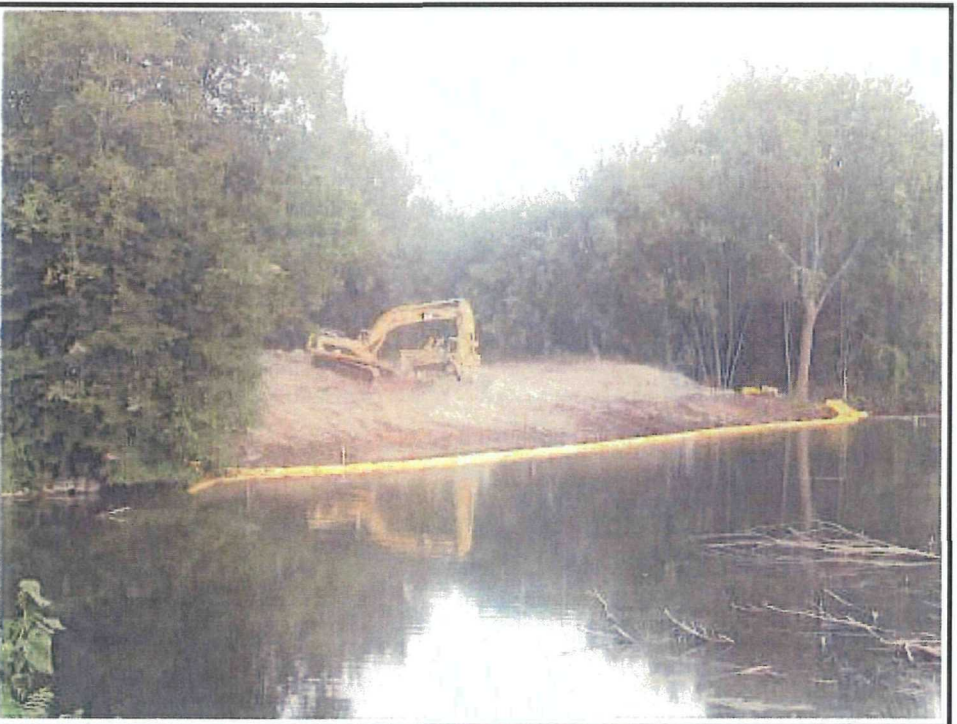
Photo No. 16	Date 8/17/2007

Description Reshaping of bank along shoreline

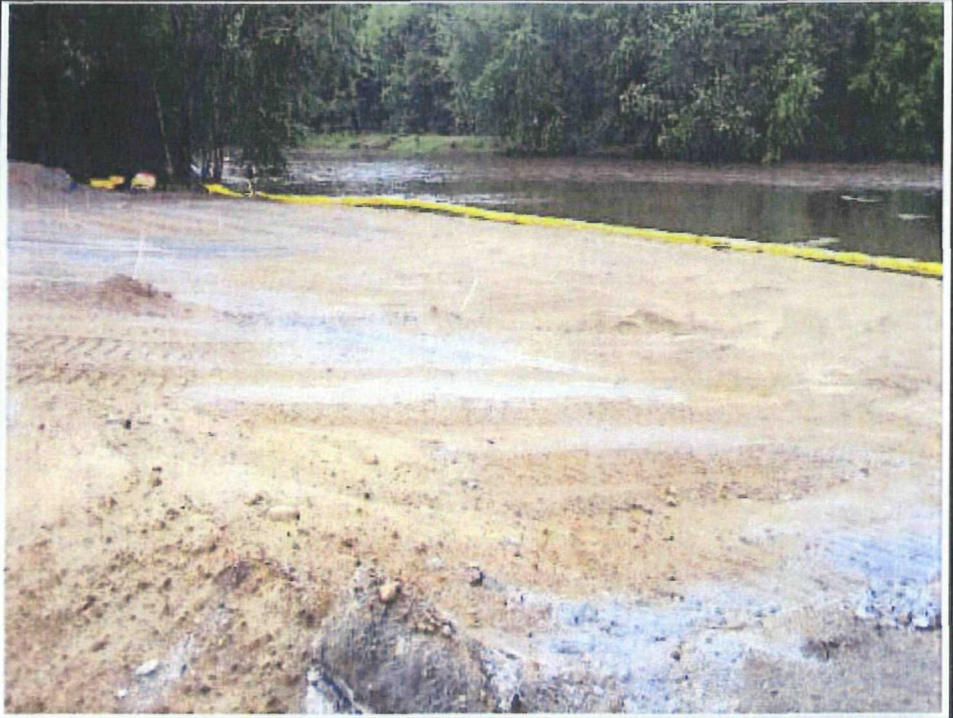
Client Name: Weyerhaeuser		Site Location: Plainwell, Michigan	Project No.: 00-05131.03
Photo No. 17	Date 8/17/2007

Description East bank of landfill reshaped for access

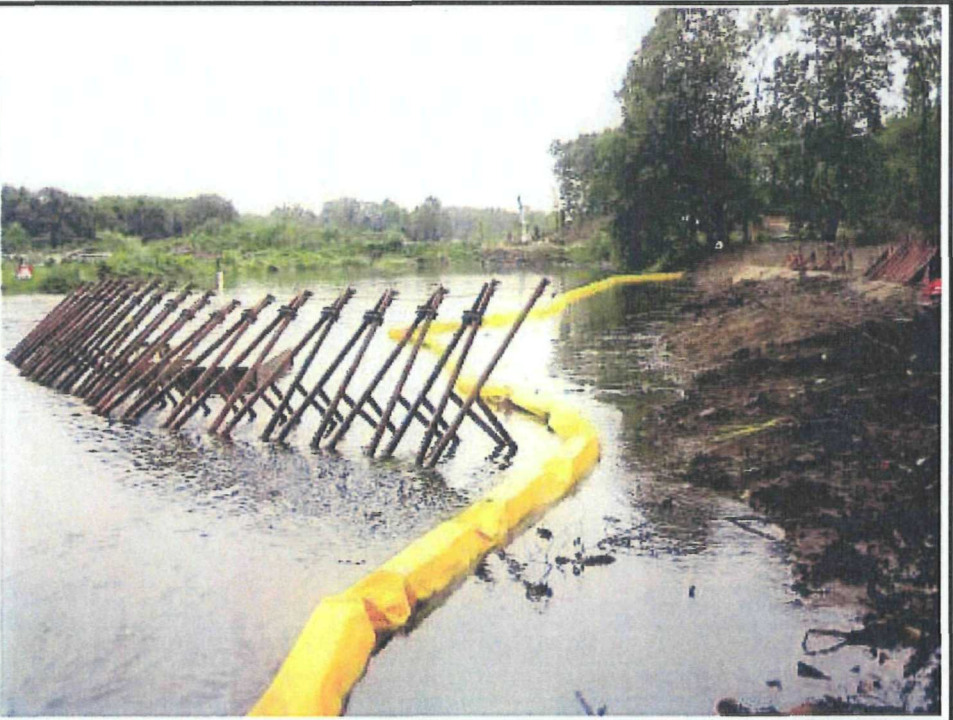
Photo No. 18	Date 8/21/2007

Description Begin setting Portadam© downstream end of channel

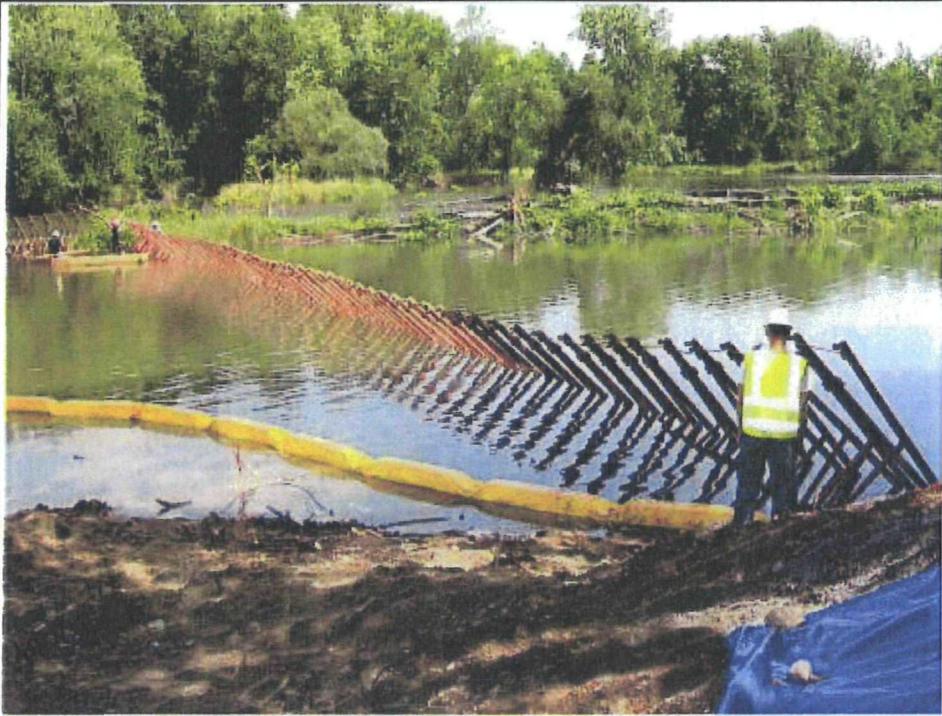
Client Name: Weyerhaeuser		Site Location: Plainwell, Michigan	Project No.: 00-05131.03
Photo No. 19	Date 8/22/2007

Description Portadam frame installation upstream end of channel

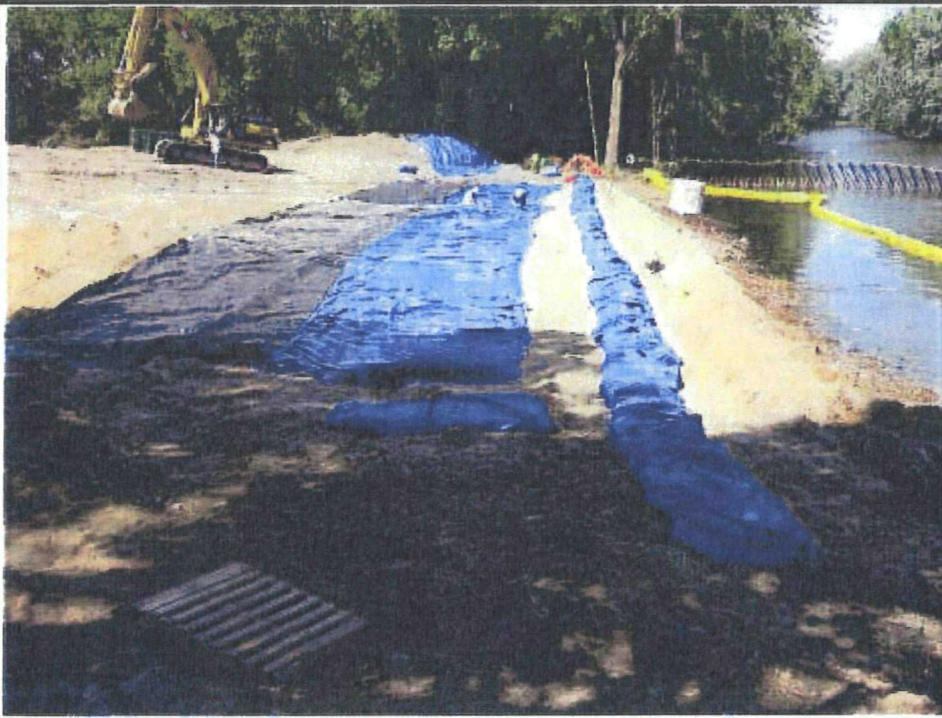
Photo No. 20	Date 8/23/2007

Description Lay out fabric for Portadam

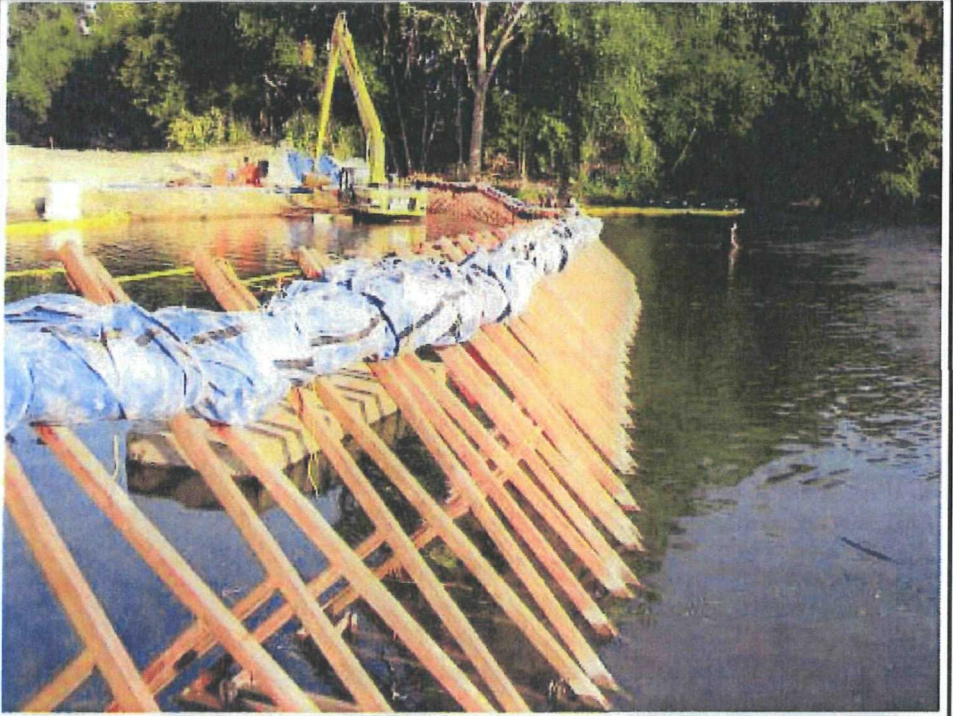
Client Name: Weyerhaeuser		Site Location: Plainwell, Michigan	Project No.: 00-05131.03
Photo No. 21	Date 9/04/2007

Description <p>Barrier seen in place on port-a-dam skeleton prior to be "rolled down"</p> <p>Placement of fabric delayed due to high flow rates in River</p>

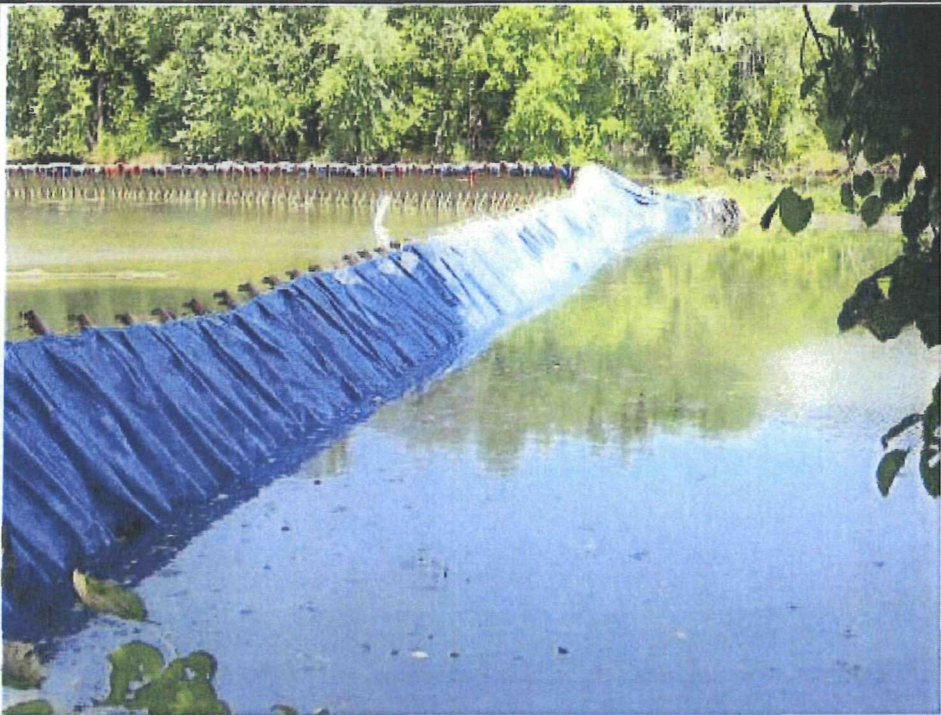
Client Name: Weyerhaeuser		Site Location: Plainwell, Michigan	Project No.: 00-05131.03
Photo No. 23	Date 9/05/2007

Description Completed Portadam – upstream side of channel

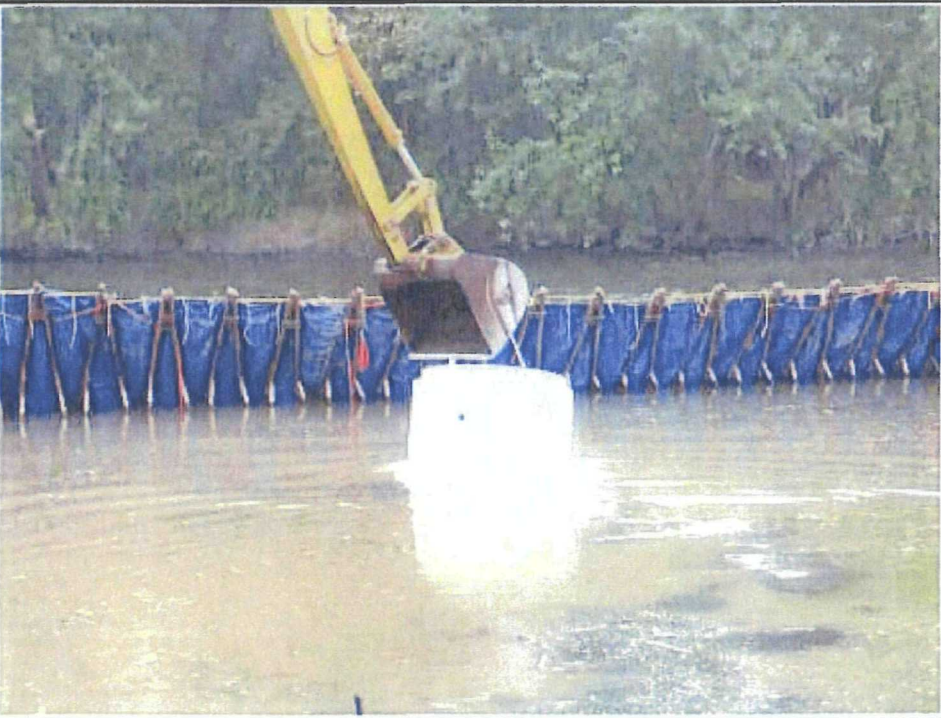
Photo No. 24	Date 9/6/2007

Description Concrete manhole to use as sump in channel

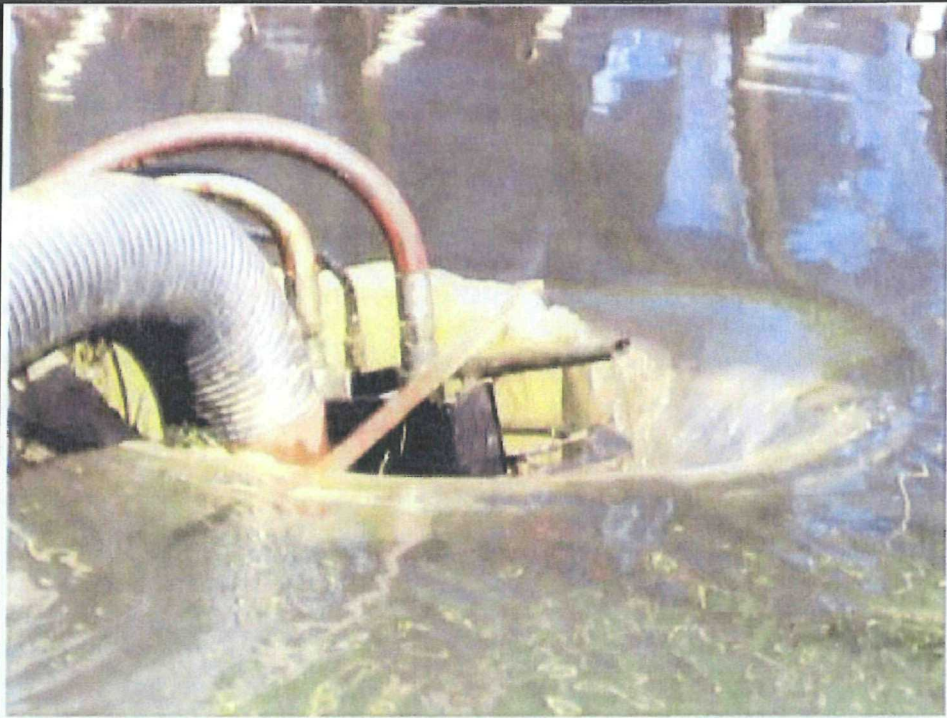
Client Name: Weyerhaeuser		Site Location: Plainwell, Michigan	Project No.: 00-05131.03
Photo No. 25	Date 9/07/2007

Description View of pump within concrete sump

A release of biodegradable hydraulic oil occurred sometime during the night of September 10, 2007, when one of the seals within the submersible pump began to leak. The pump was shut down as soon as the problem was identified. Based on the fluid within the reservoir, approximately 2 to 3 gallons of the material was released. The majority of fluid was contained within the secondary containment area and absorbent pads were used to remove as much of the residual fluid as possible. A new pump was delivered to the site and placed within the channel area and the defective pump removed from the site. The release was reported to the National Response Center and a copy of the report is attached as Appendix E.

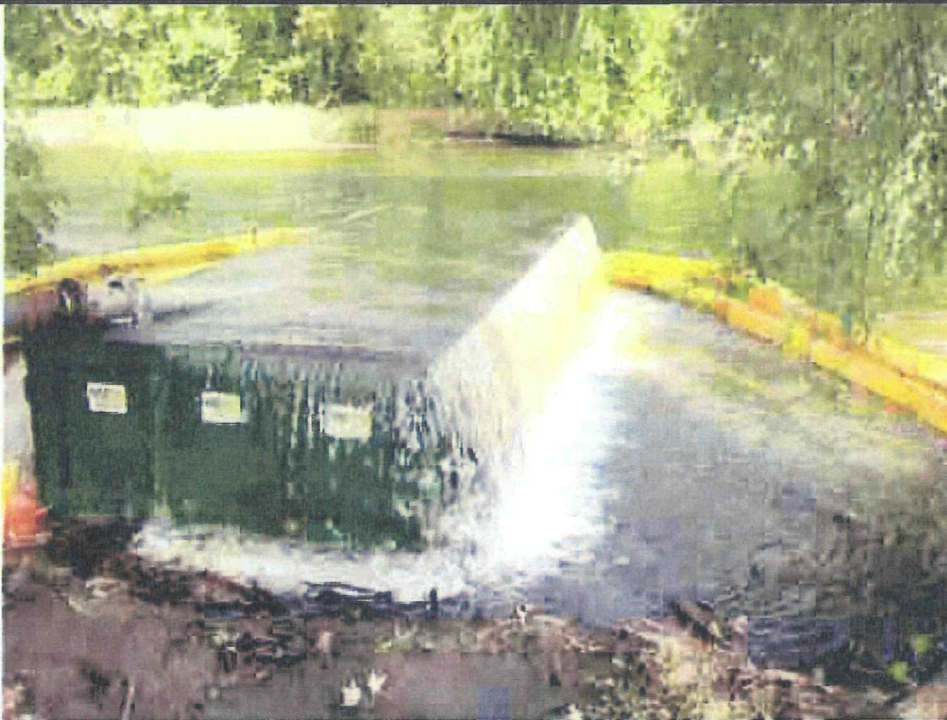
Photo No. 26	Date 9/07/2007

Description Discharge diffuser from pumping down channel with secondary containment with silt curtains

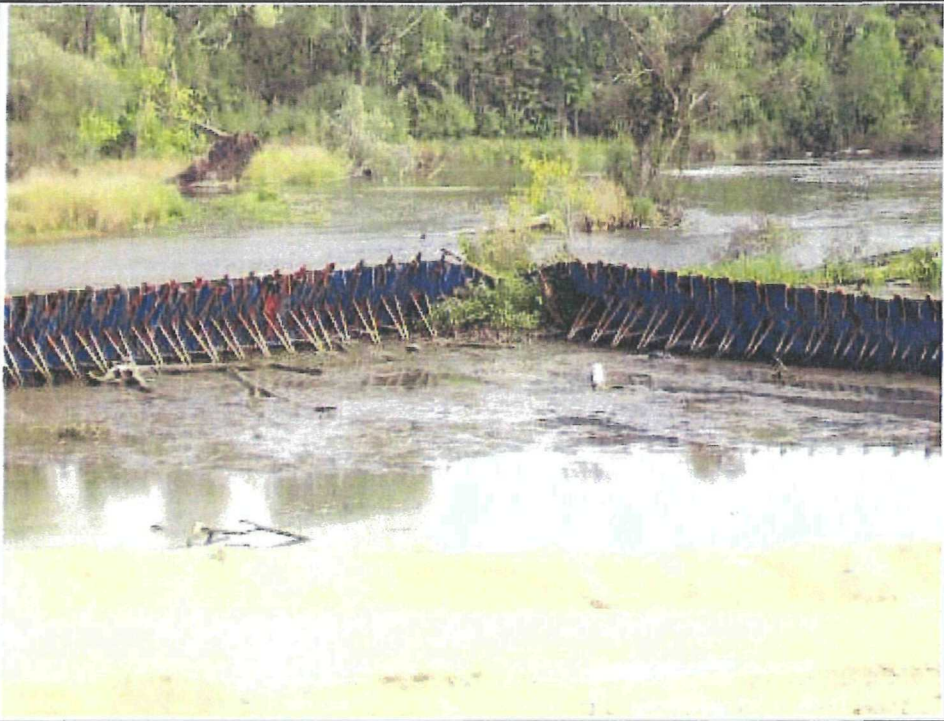
Client Name: Weyerhaeuser		Site Location: Plainwell, Michigan	Project No.: 00-05131.03
Photo No. 27	Date 9/7/2007

Description View of contained area after significant pumping has occurred.			
Photo No. 28	Date 9/07/2007

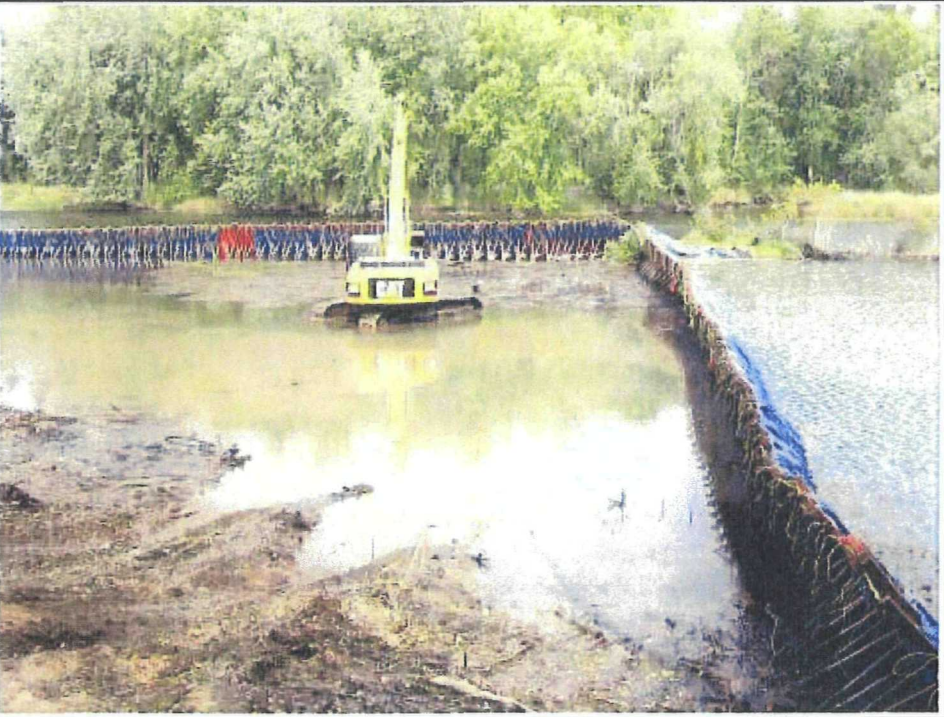
Description Begin excavating material from channel
